# **HANDBOOK ON CASTING AND OTHER DEFECTS**

In Gold Jewellery Manufacture

*by Dieter Ott*

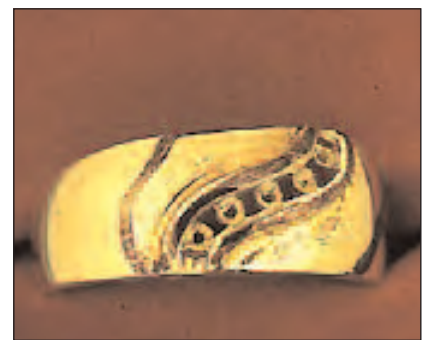
Fig. 2.2 Another example of the same kind of defect

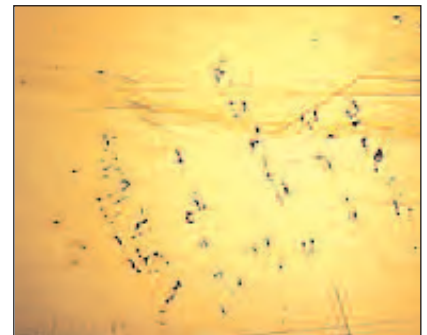
Fig. 2.3 Typical example at higher magnification 100 x

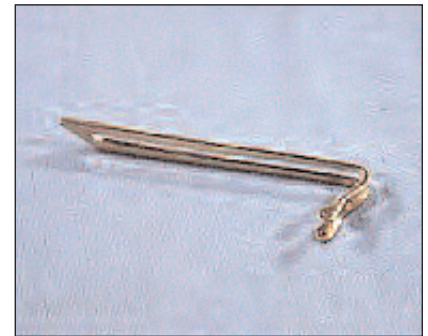
Fig. 5.1 Tie Clip

The defect is an other exemplary case of shrinkage porosity. However, in this case, the gating of the wax is a critical point. The gate itself is short and sufficiently thick for supplying melt during solidification. However, the positioning of the gate on the wax model has to be criticised. The molten metal, fed to one end of the clip, has to be transported through thin bridges to the other, thicker end. The melt freezes on its way through the thin cross-sectioned part, resulting in an insufficient supply to the other end of the clip and, hence, severe shrinkage porosity occurs there.

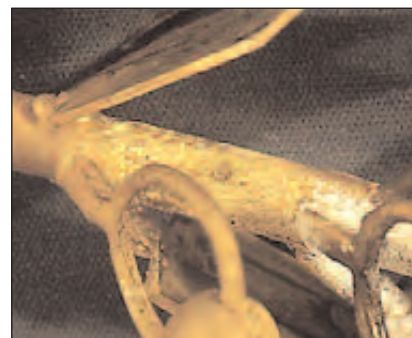
Fig. 10.1 Surface of central sprue

Growth of crystallites at the onset of solidification manifests itself as a dendritic shape. The residual melt remains in the inter-dendritic space. If the melt does not wet the investment at the mould wall and decomposition of the investment gypsum binder causes the formation of sulphur dioxide gas, the residual melt is pushed away from the surface,

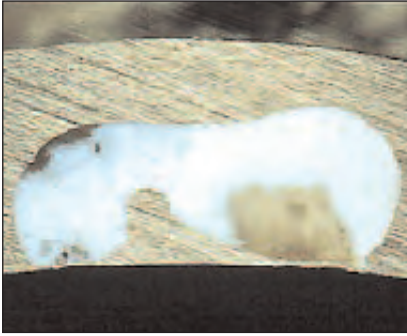
Fig. 11.4

An example from another defect case, fig 11.4, reveals an investment inclusion of considerable size. Such examples, with the inclusion completely retained after surface treatment and sample preparation, are not very usual.

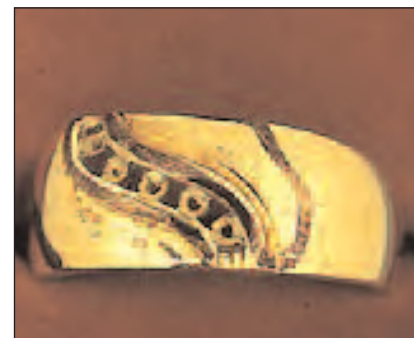
Fig. 12.1 Surface porosity caused by impurities.

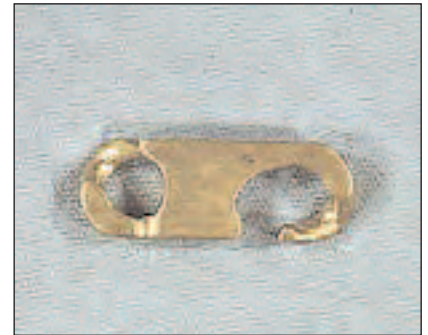
Fig. 14.1 A spring hook with surface porosity

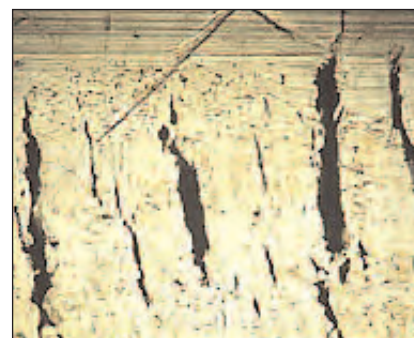
Fig. 15.1 Surface of the ring approx 20 x

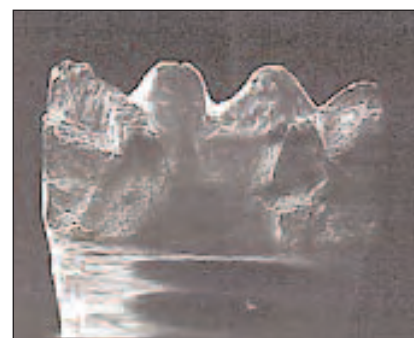
Fig. 17.4 SEM of fracture surface

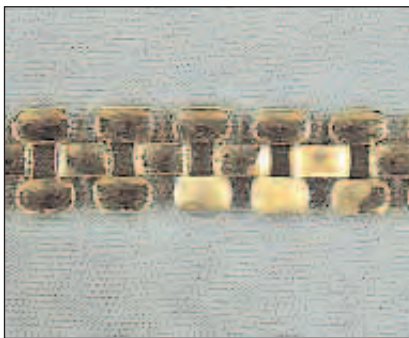
Fig. 22.2 This example shows the stained surface in more detail

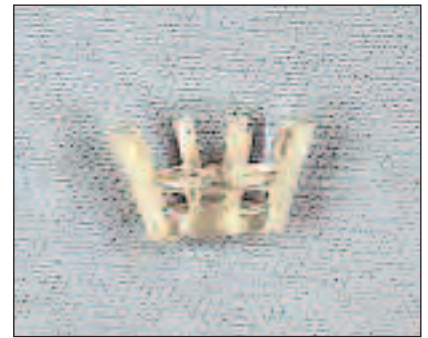
Fig. 24.1 Broken prong on a white gold finding

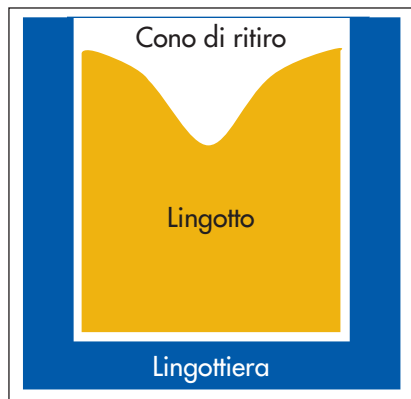
Figure 2 Schematic: Shrinkage cavity (primary pipe) on top of a cast ingot
