## **BP Process Safety Series**

# **Control of Work**

**A collection of booklets  
describing hazards and  
how to manage them**

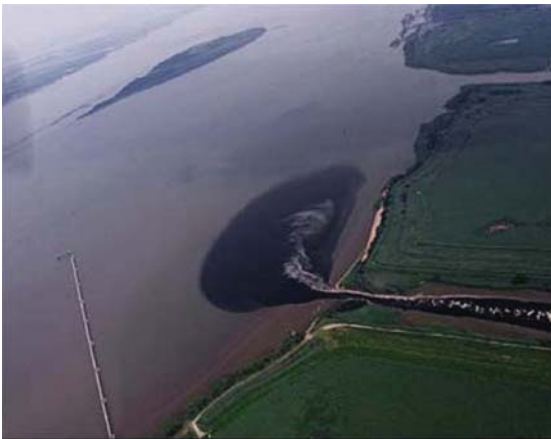
*Acid spill into the nearby river*

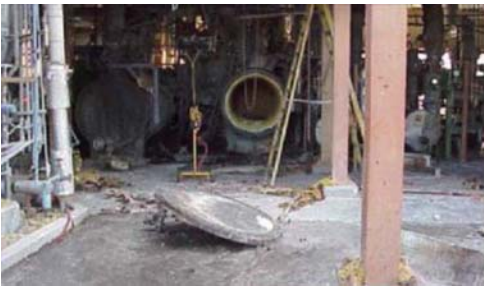
Three workers were preparing to open and remove polymer from a polymer catch tank. All three employees began removing the bolts on the 5-foot (1.5m) cover plate of the tank. After half the bolts had been removed, the internal pressure within the catch tank caused an explosion which ripped off the cover plate, striking and fatally injuring the three workers. Another explosion occurred six minutes later and a fire ensued.

*The cover plate blew off this polymer catch tank, killing three workers*

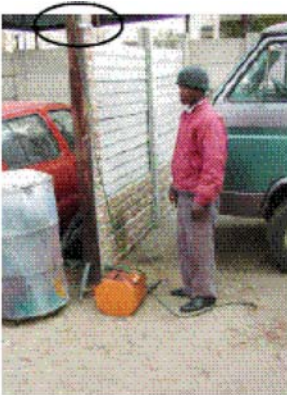
The empty drum, which originally stored flammable materials, contained a flammable atmosphere. There were fumes in the drum that were heavier than air, some of which had escaped out of the inlet hole of the overturned drum. When the welding operation began, sparks from the welding ignited the flammable vapour. The flame travelled into the drum, igniting the vapour inside, causing the explosion.

*A reconstruction of the scene as it was before the explosion. The welding assistant, the drum, and the welding machine in position. Circle denotes welding position*

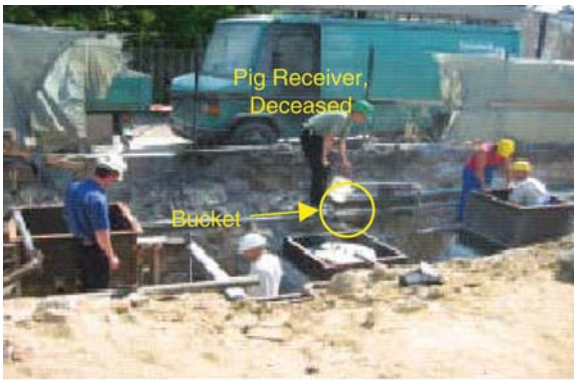
*Re-enactment of the incident*

Five workers were working in the excavated pit at the start of a line purging operation (as seen in the photograph above). A plastic bucket of less than 20 litres (5 gallons) capacity was used to collect the pig and gasoline from the pipe. Unknown to them, there was approximately 29 litres (8 gallons) of gasoline in the pipe being purged. The container, being too small to accommodate the contents of the pipe, overflowed and resulted in a gasoline spill. The fuel was ignited by the hot work in the pit, causing serious burns to one worker (who later died), significant burns to another, and minor burns to the remaining three.

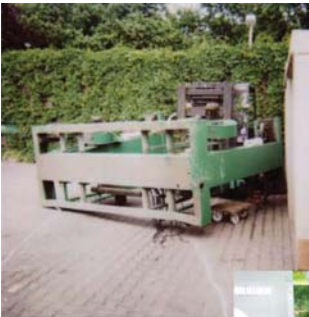
*The technician was trapped between the gantry and garage wall*

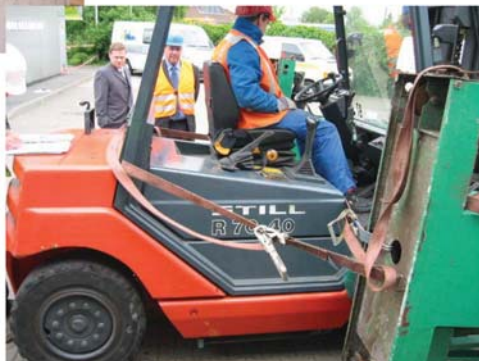
*Reconstruction of the incident. The retaining strap passes behind the driver's heels*

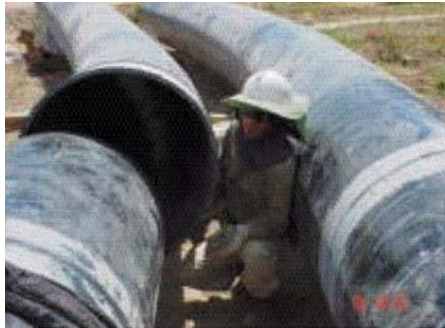
*Position of the injured person at the worksite*

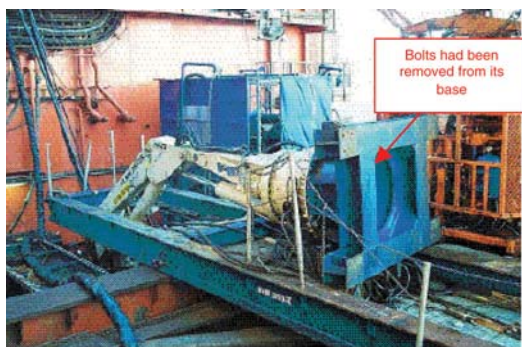
A check revealed that in its new position, the crane panel might obstruct a walkway. Wanting to ensure that the crane had direct access to the new well, the service supervisor started to operate the crane, having forgotten that the securing bolts at the base had been removed. After unfolding the boom, the crane became unbalanced and toppled over, narrowly missing the supervisor. He escaped death by a small margin. Extensive external damage was sustained to drilling and SIMOPS equipment with costly delays and repairs.

*Toppled SIMOPS crane*

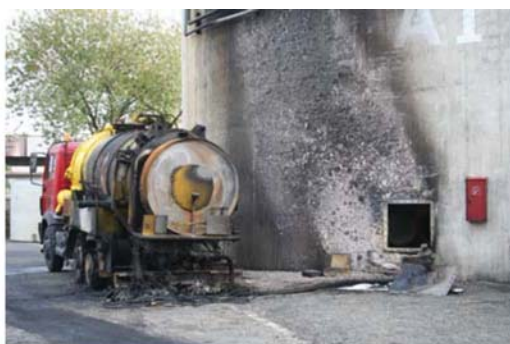
Explosions and a subsequent fire occurred during the cleaning of a 2,500 m<sup>3</sup> gasoline tank. A vacuum truck was destroyed; the tank and its concrete bund wall were heavily damaged. At the time of the incident, product had been pumped out and the tank was isolated for entry. Vapours from the tank entered the truck engine air intake, the truck engine raced (over-speeding) and immediate attempts to decelerate it from the control panel at the back of the truck were not successful.

*Destroyed truck and fire damage on concrete bund wall*

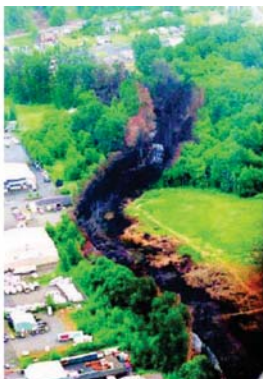
A 16-inch (41 cm) buried steel pipeline ruptured and released 237,000 gallons (900 m<sup>3</sup>) of gasoline into a creek. About an hour and a half later, the gasoline ignited and burned approximately 1½ miles (2.4 km) along the creek. Three people died and eight were injured. Total property damages were estimated to exceed \$45 million.

*Aerial view of the fire damage*

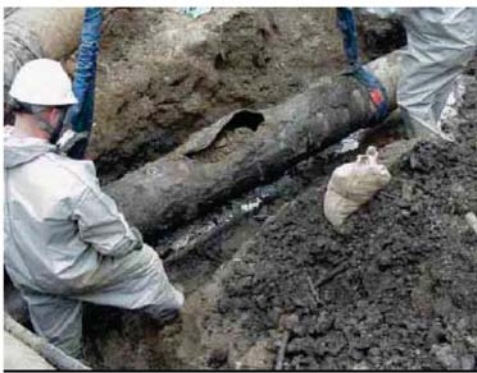
*Removal of ruptured pipe section*

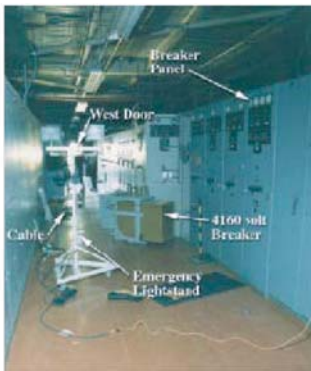
*Switchgear looking towards the exit door*

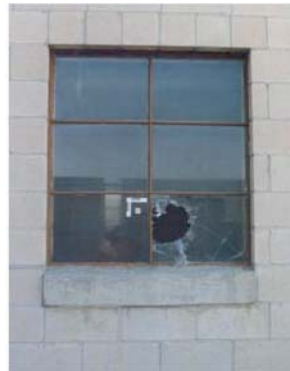
*Broken window*

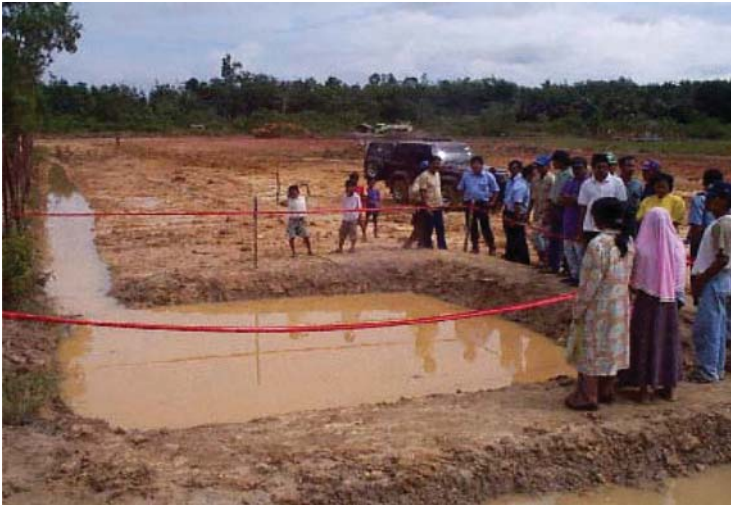
*Three young children tragically drowned in this pit. The pit had not been barricaded to prevent access. No signage had been put up to warn against entry (for example, deep water, keep out, no swimming, no fishing, etc.).*
