# Bearing damage and failure analysis

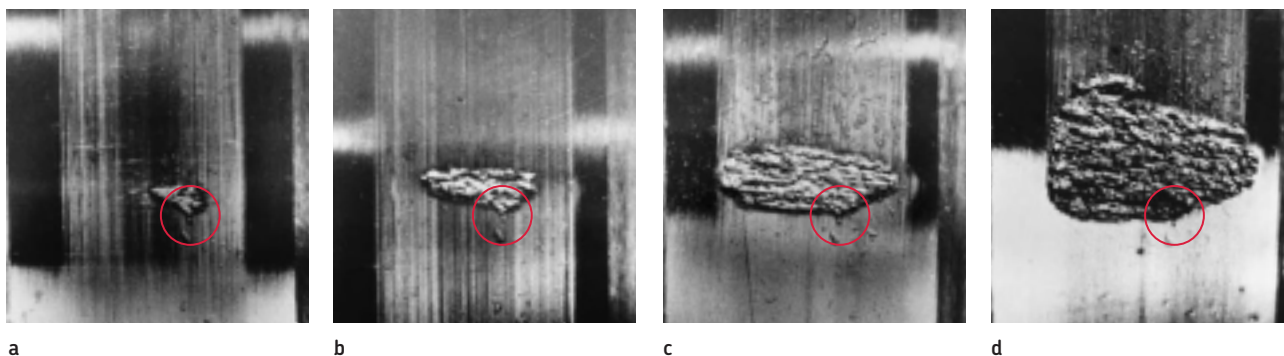
Fig. 1

A hard contaminant was over-rolled and made an indentation in the inner ring raceway of a cylindrical roller bearing (a). The surface initiated fatigue resulting in a spall started just behind the indentation. Over a period of time, spalling became more and more pronounced (b, c). If the machine was not stopped in time, secondary damage to machine components could have occurred. The initial indentation is no longer recognizable (d).

**Fig. 1** shows the progress of damage as illustrated in **diagram 1**:

- 1 Bearing exhibits incipient abrasive wear.
- 2 First spall, detected by SKF enveloped acceleration technology.
- 3 Spalling has developed to an extent that the damage can be detected by standard vibration monitoring.
- 4 Advanced spalling causes high vibration and noise levels and an increase in operating temperature.
- 5 Severe damage occurs: fatigue fracture of the bearing inner ring.
- 6 Catastrophic failure occurs with secondary damage to other components.

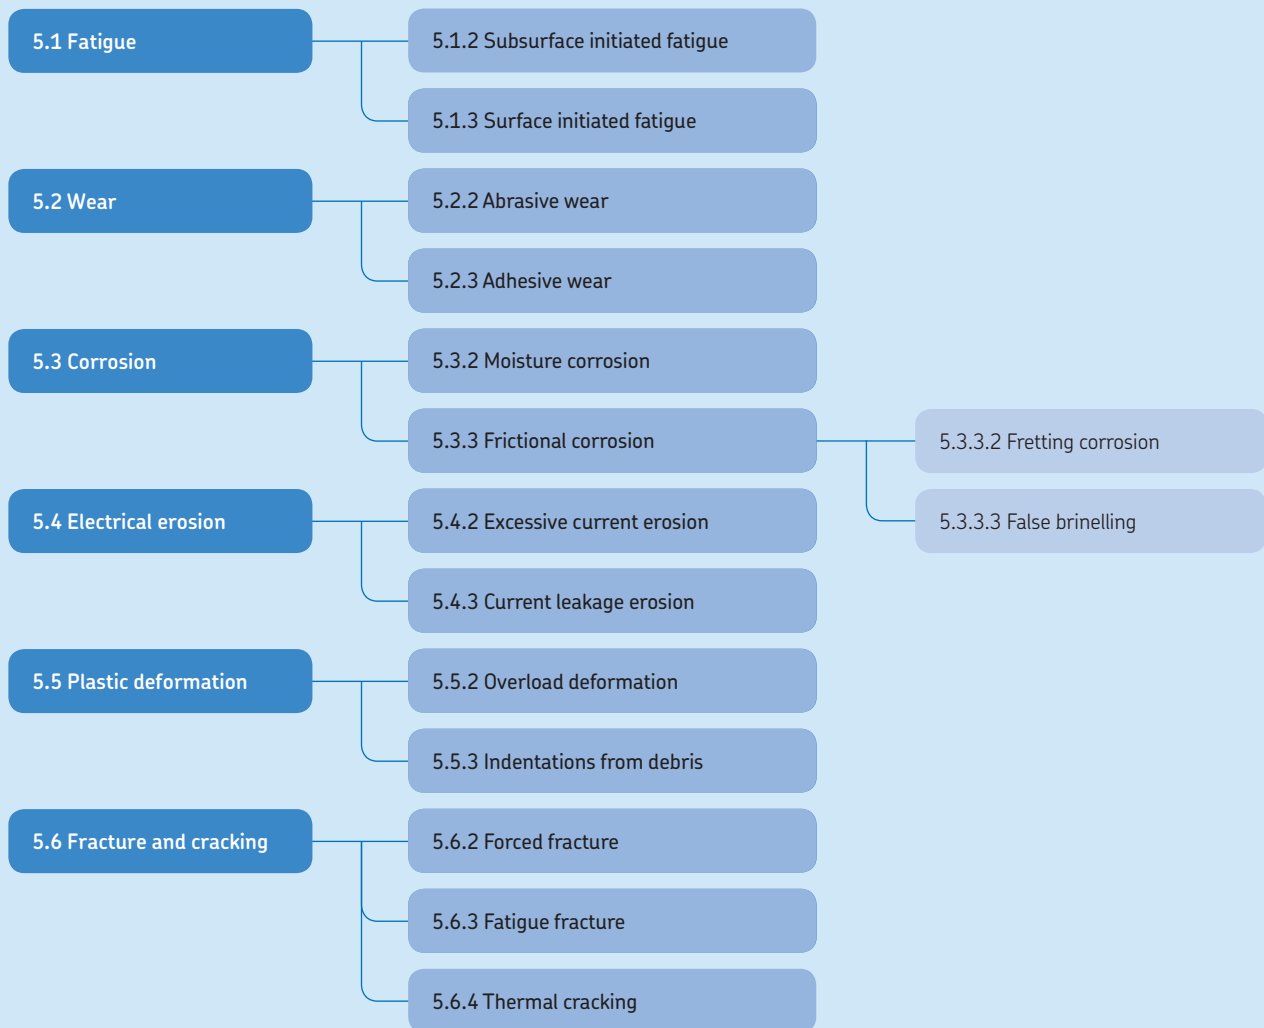
SKF classification adapted from ISO 15243:2004

Numbering follows ISO 15243:2004 subclause numbers.

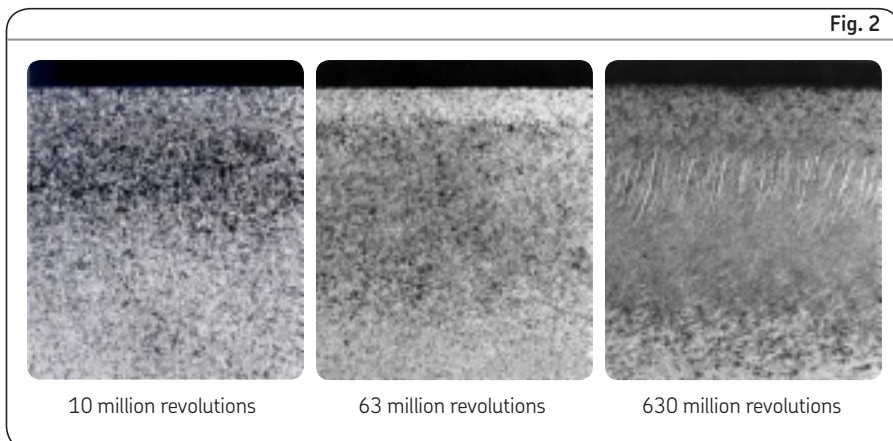
Changes in structure beneath the raceway surface over time (highly stressed, well lubricated small deep groove ball bearing)

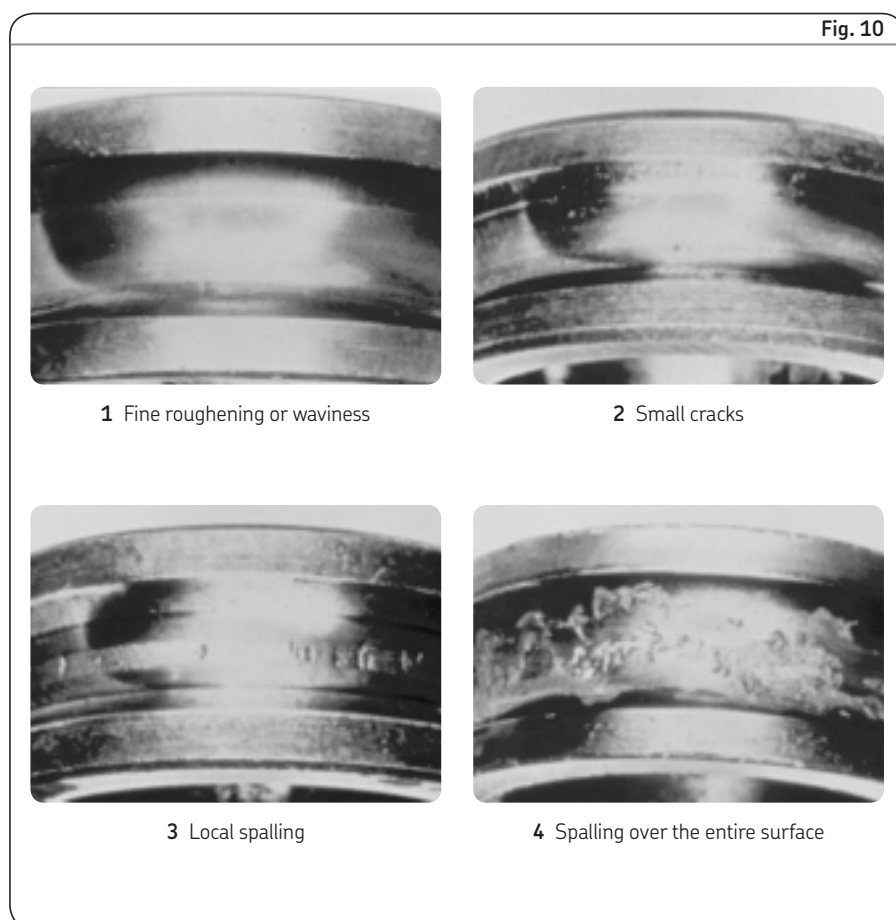
*Progress of surface initiated fatigue on the inner ring of a deep groove ball bearing*

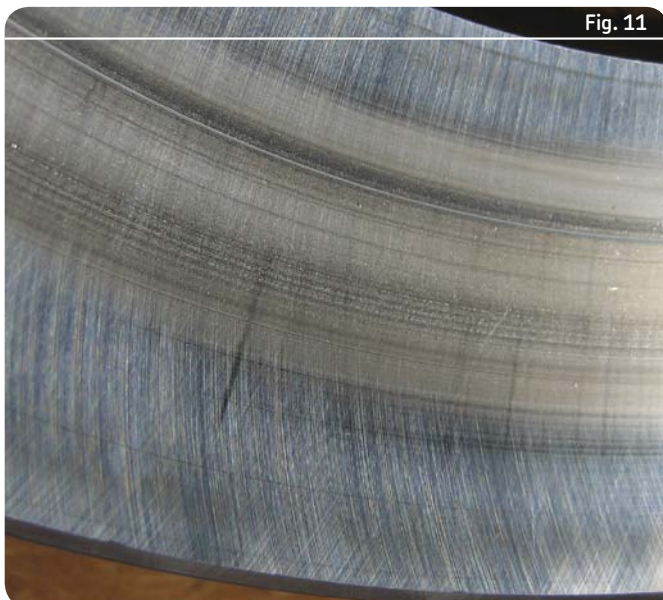
**Light abrasive wear on the outer ring of a spherical roller thrust bearing**

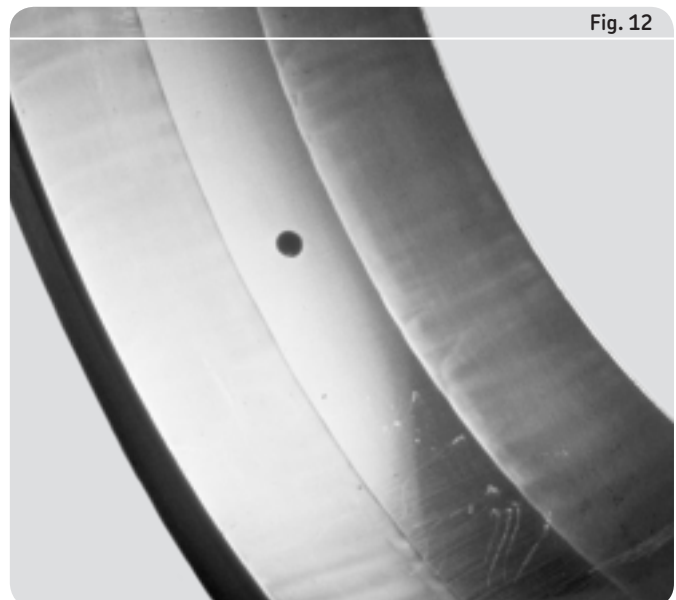
**Advanced abrasive wear on the outer ring of a spherical roller bearing (dull and matt raceways)**

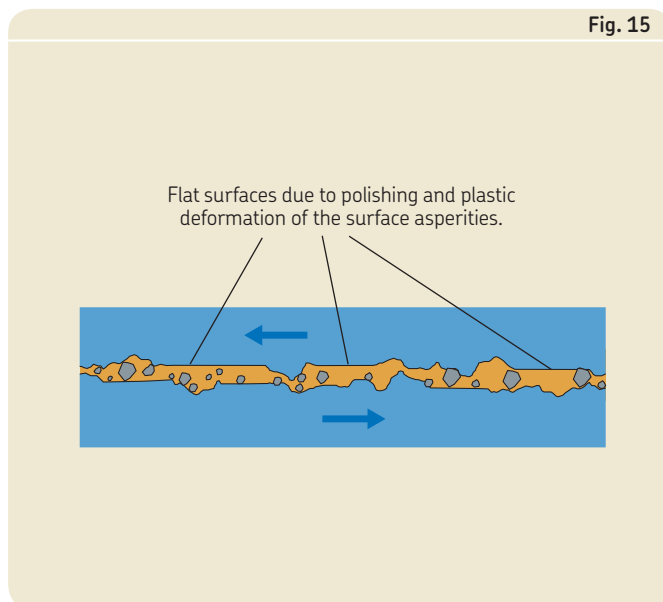
**Fig. 15**

*Process of polishing wear in a bearing*

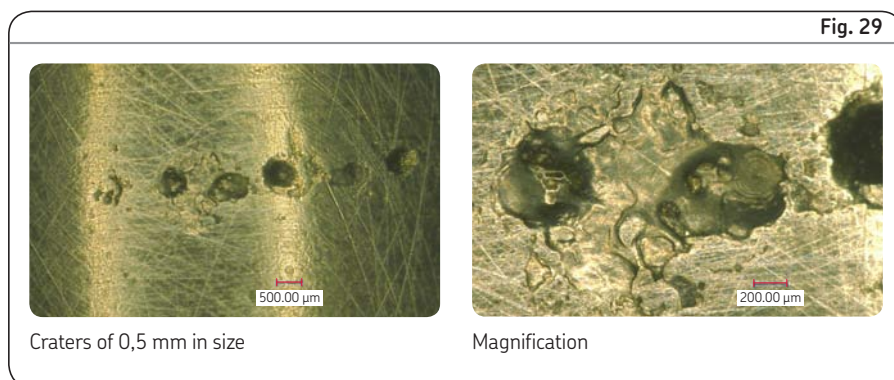
#### Excessive current erosion on the roller of a spherical roller bearing

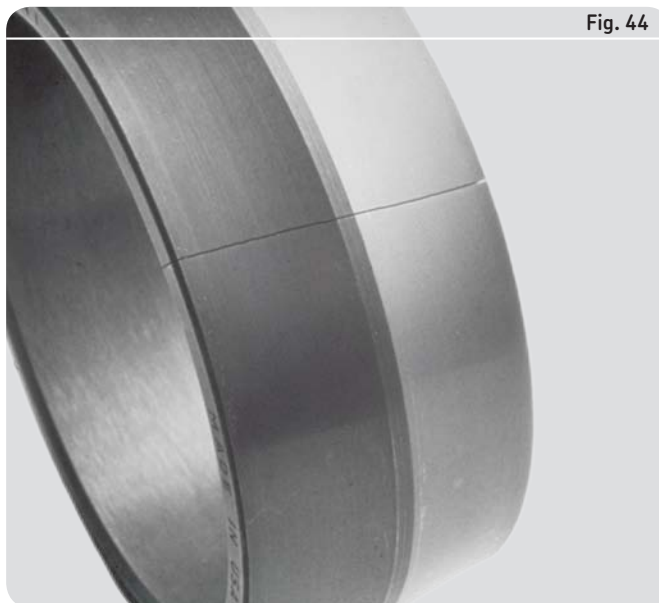
Fig. 44

*Fracture on the large shoulder of a tapered roller bearing inner ring resulting from rough treatment*

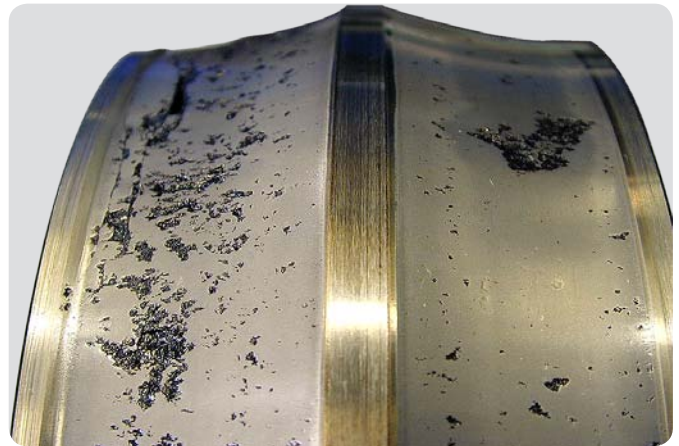
**Spherical roller bearing inner ring**  
*Inadequate lubrication, surface distress with incipient spalling*

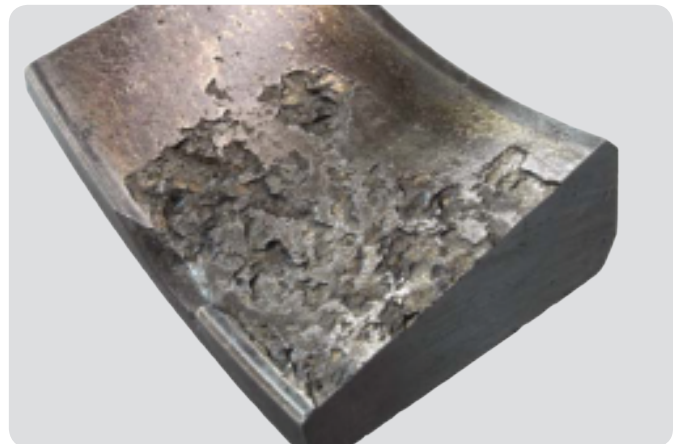
**Spherical roller bearing outer ring**  
*Initially, abrasive wear due to contamination, developed into surface distress and advanced spalling*

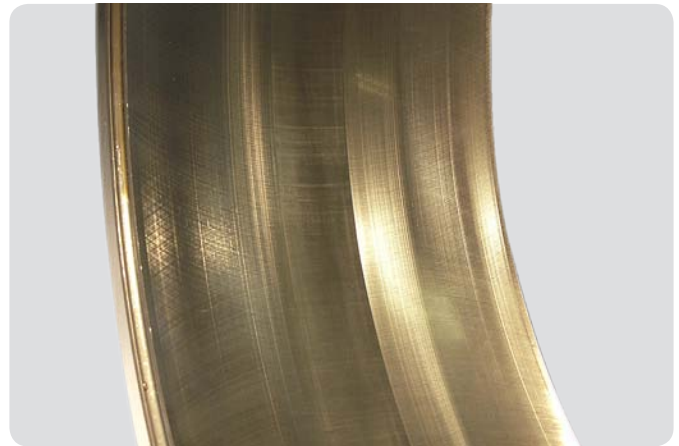
**Spherical roller bearing outer ring**

*Contamination and resulting inadequate lubrication leading to abrasive wear of the raceway tracks – slightly shiny*

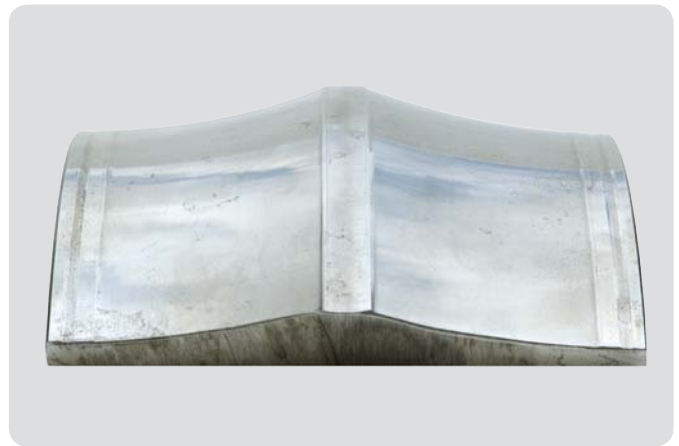
**Spherical roller bearing inner ring**

*Abrasive wear of the raceway tracks. The axially loaded one also partly discolored indicating inadequate lubrication and heat generation. The other raceway track shows a narrower load pattern with a matt appearance.*

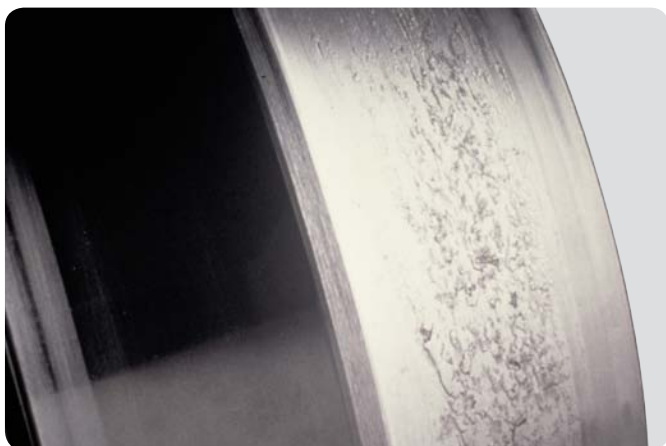
**Spherical roller bearing inner ring**  
*Too low load combined with inadequate lubrication*

- Make sure the bearing is adequately loaded
- Make sure the sealing arrangement is operating efficiently
- Consider bearing downsizing
- Verify lubricant selection (viscosity, AW and EP additives)
- Consider using coatings
- Consider using hybrid bearings

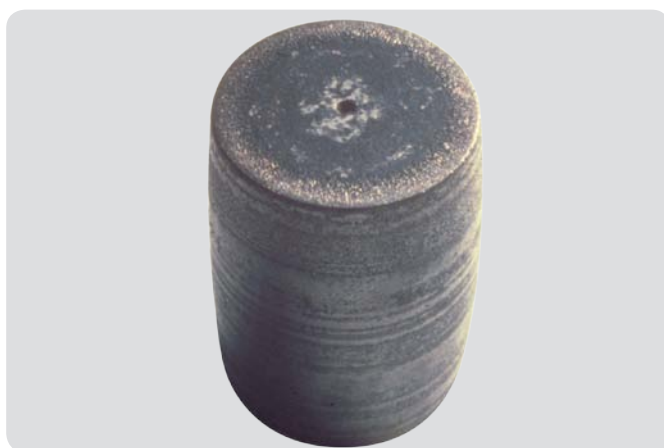
**Spherical roller bearing – roller**  
 Corroded roller due to severe water penetration into the bearing

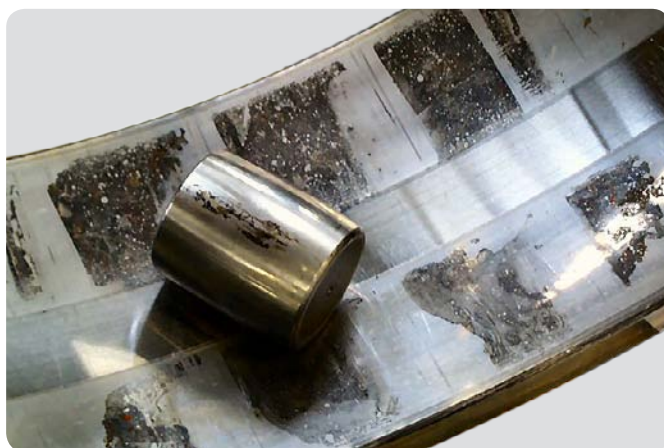
**Spherical roller bearing outer ring and roller**  
 Too high water content in the lubricant, standstill corrosion of raceway at roller pitch

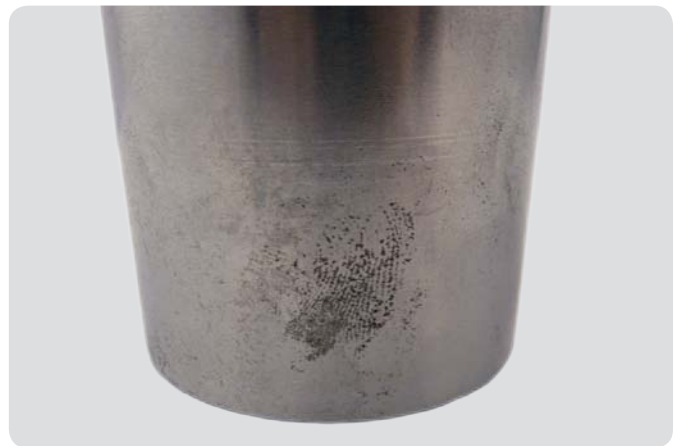
**Tapered roller bearing – roller**

*Sealing arrangement failure, corrosion at standstill*

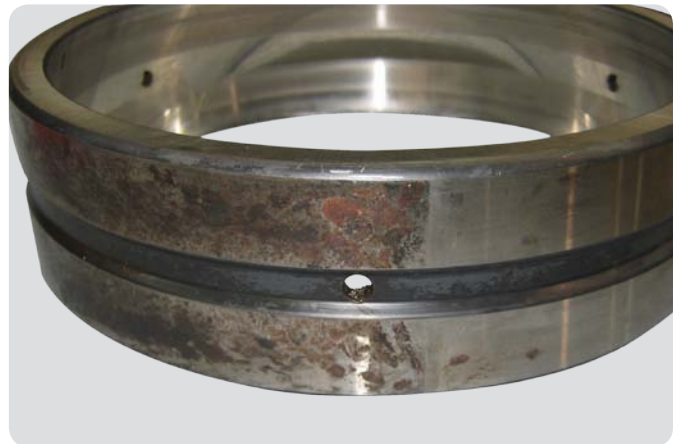
**Spherical roller bearing outer ring**  
Inadequately supported ring

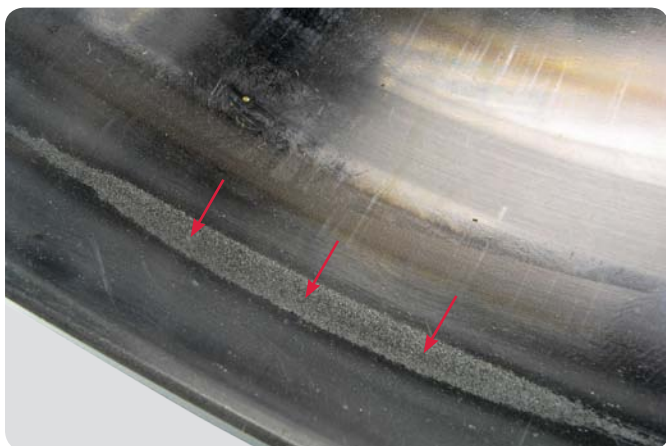
**Spherical roller bearing outer ring**  
Damage in early stage: dull grey zone with small shallow craters

- Use symmetric cabling
- Make sure the stator and rotor are properly aligned
- Use insulated bearings (INSOCOAT or hybrid bearings)
- Make sure earthing connections are installed properly

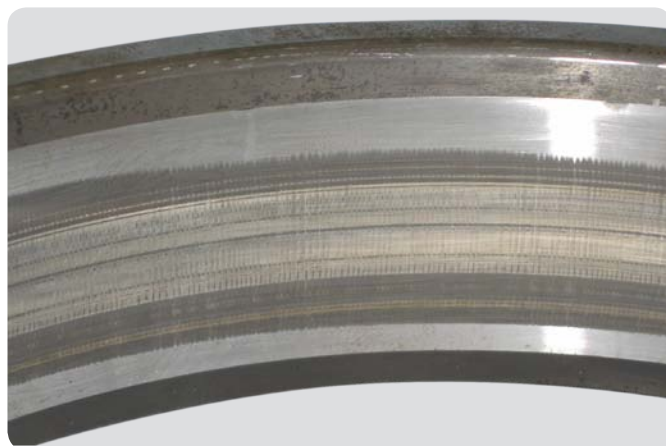
**Cylindrical roller bearing outer ring**  
Early stage of washboarding

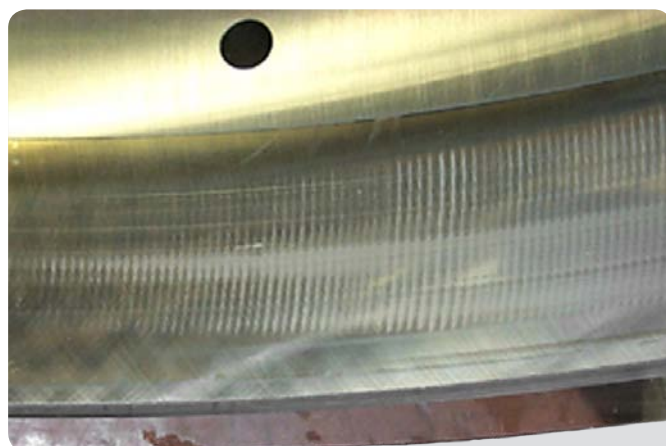
**Spherical roller bearing outer ring**  
Current leakage

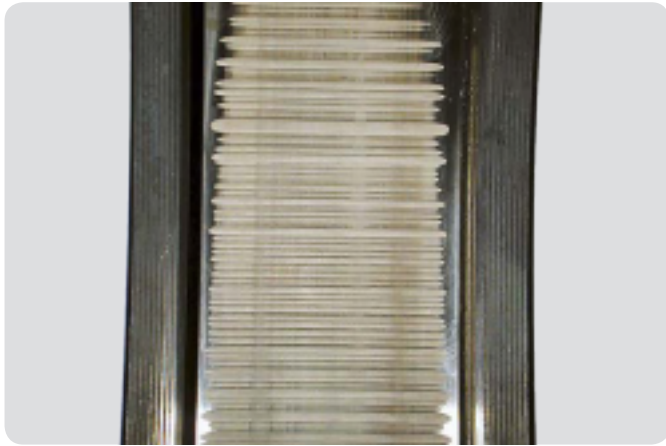
**Cylindrical roller bearing outer ring**  
Advanced stage of washboarding

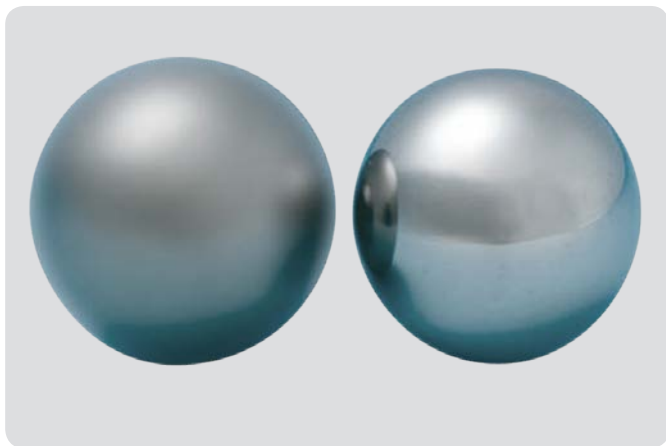
**Deep groove ball bearing – balls**  
Left: damaged ball – dull surface  
Right: new ball – shiny surface

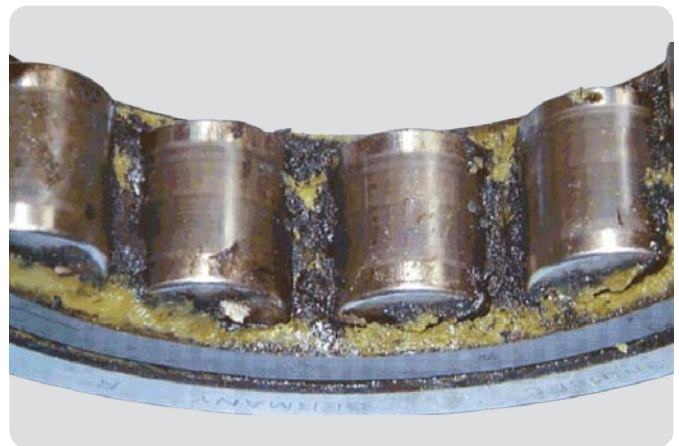
**Cylindrical roller bearing outer ring with cage, rollers and grease**  
Current leakage resulted in burnt grease (black) on the cage bars

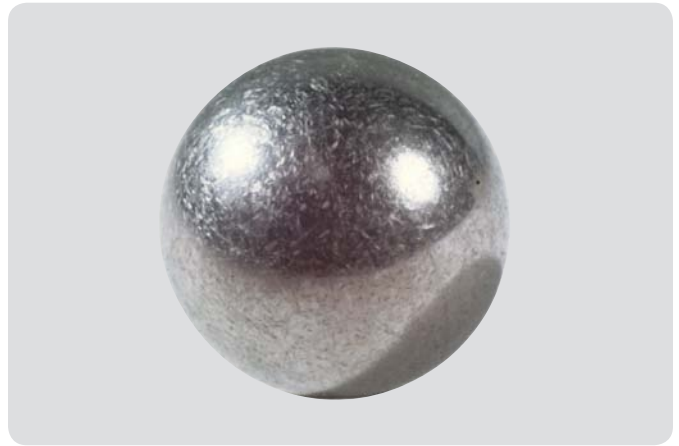
**Deep groove ball bearing – ball**

*Overrolling of big and hard particles that entered the bearing due to inadequate sealing arrangement*

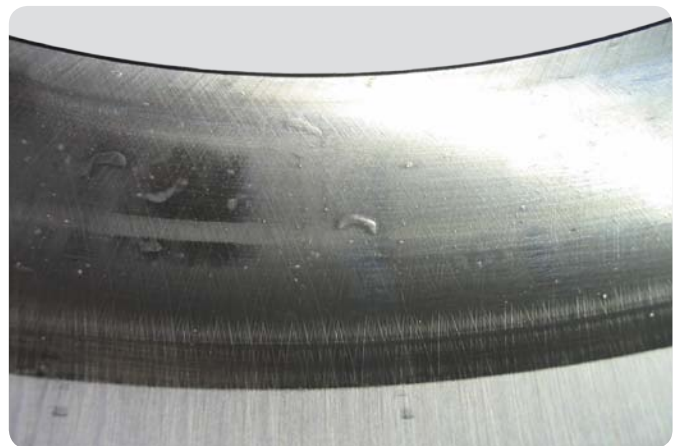
**Spherical roller bearing outer ring**

*Overrolling of particles with sequential spalling starting at the back of the dents*

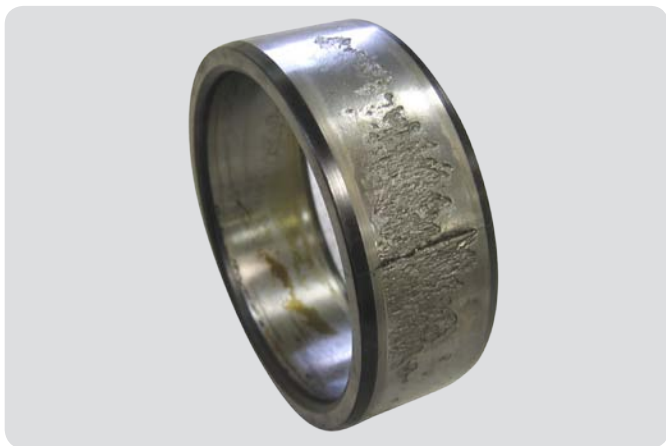
**Cylindrical roller bearing inner ring**  
*Very heavy spalling – fatigue fracture as sequential damage*

- Make sure bearing seats conform to geometrical specifications
- For split housings, make sure the two halves join correctly
- Bearing seats should be clean (no swarf or chips, which could create local stress rise)
- Use appropriate tools and methods for mounting

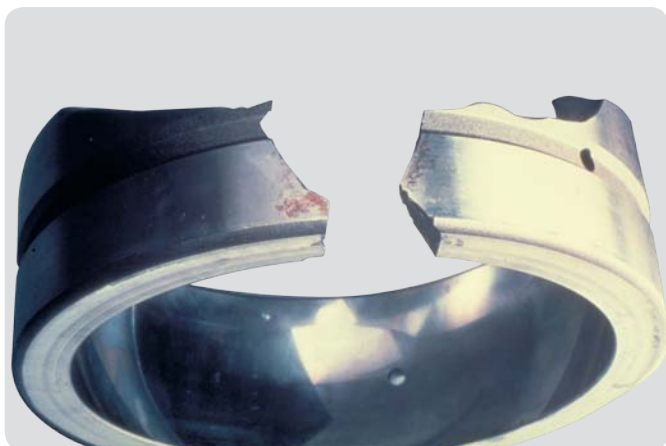
**Spherical roller bearing outer ring**  
*Fatigue fracture resulting from inadequate housing seat (swarf trapped at the bottom of the housing)*

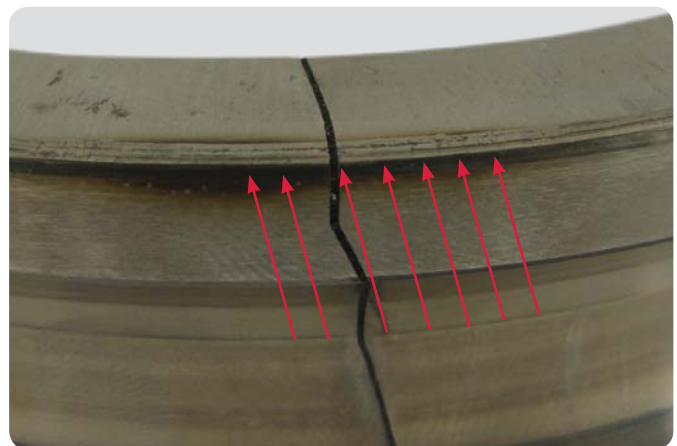
**Deep groove ball bearing inner ring**  
Enlarged view of fractured ring, with many heat cracks along the inner ring shoulder

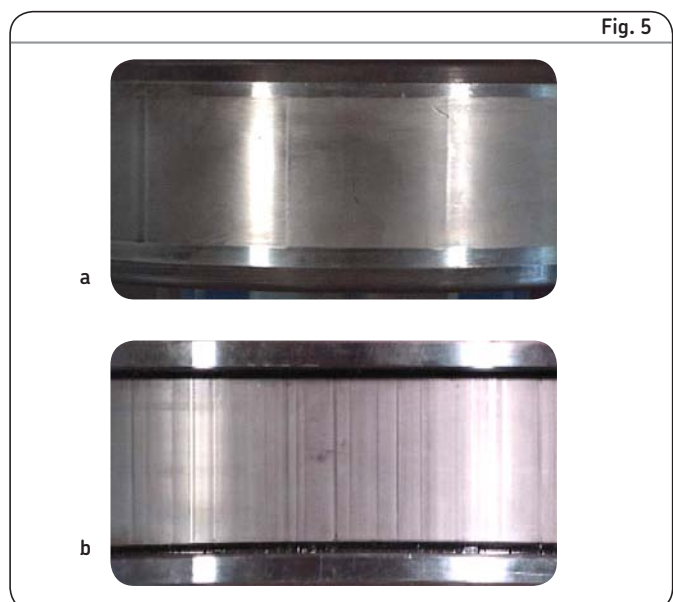
### Heavy wear and vibration marks on the inner ring (a) and outer ring (b) raceways of the cylindrical roller bearing

When the bearing was cut, and a section put under a microscope, some interesting conclusions could be made:
