## RISK BASED INSPECTION (RBI) ASSESSMENT AT ABOVEGROUND STORAGE TANKS (ASTs)

This paper presents the step by step implementation of API RBI technology to conduct risk based assessment on four bulk plants for 10 storage tanks in diesel and gasoline services. In this assessment, the API-RBI methodology was used based on API Publication 581, 2<sup>nd</sup> Edition, September 2008 and API-RBI software version 8.03.03.

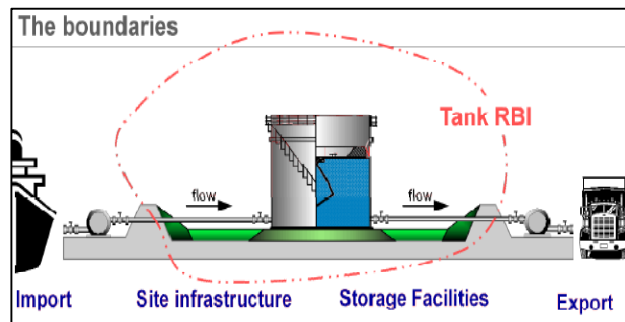
**Figure 1 - The Boundary of the RBI Assessment**

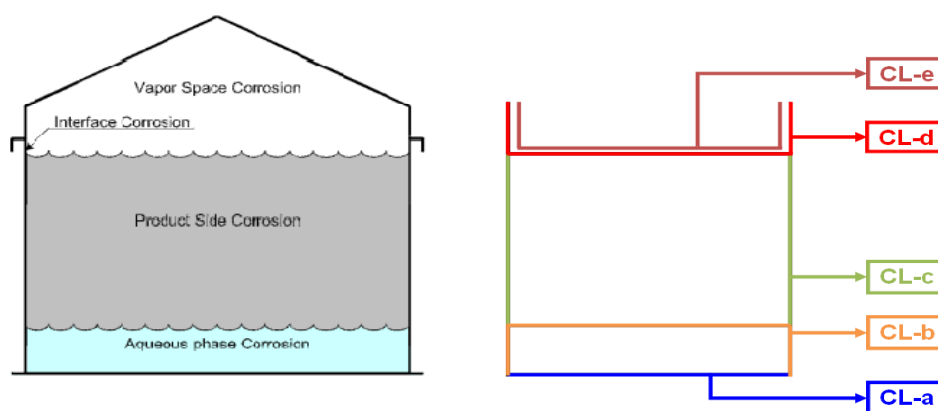
**Figure 2 - Corrosion Loop Sub-division for Tank**

In order to aid a structured approach to the tanks under assessment, corrosion loop for tank is subdivided into five (05) sub-loops as under:

1. CL-a for Tank Bottom
2. CL-b for Tank Bottom Shell
3. CL-c for Tank Middle Courses
4. CL-d for Tank Upper Course
5. CL-e for Tank Roof

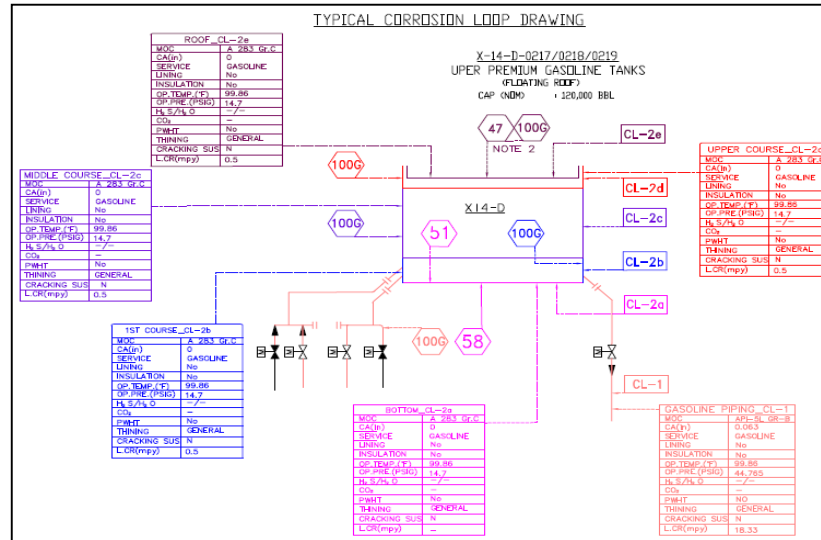
like  $H_2S$ ,  $CO_2$  etc. A typical corrosion loop drawing in Figure-3 shows the unique color for each corrosion loop and encircled number for the identified damage mechanisms as per API 571.

**Figure 3 - Typical Corrosion Loop Drawing for Tank**

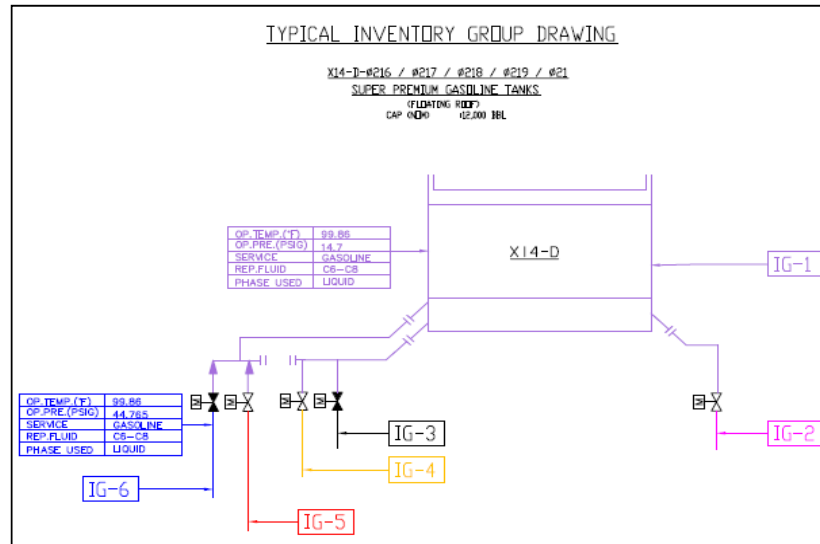
Inventory group is used to determine the mass/volume of fluid that could realistically be released in the event of a leak. The inventory group is used to designate a grouping of equipment that can be remotely isolated from other sections of the plant in an emergency situation. When a component or piece of equipment is evaluated, its inventory is combined with inventory from other attached equipment that can realistically contribute fluid mass to the component that is leaking.

**Figure 4 - Typical Inventory Group Drawing for Tank**

The typical inventory group drawing is presented in Figure-4 below.

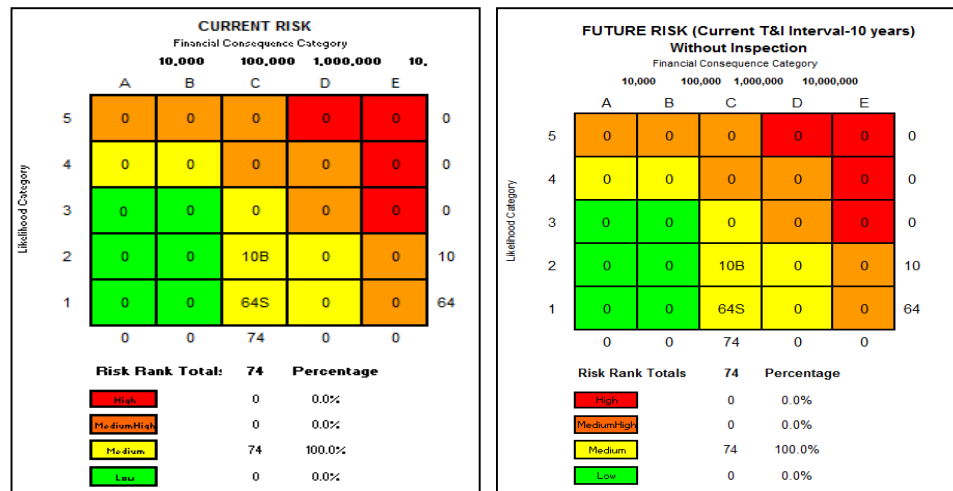
Figure 5 - Risk Comparison between Current (2012) and Future with 10-Years Turnaround Interval

**Note:** "B" represents the Bottom/Floor and "S" represents the Shell courses of the tank in the risk matrix.

The main observations from Figure 5 are as follows:

- The overall current risk distribution for seventy four (74) components tanks shows zero components at HIGH RISK, zero components at MEDIUM HIGH RISK, seventy four (74) components (100%) in the MEDIUM RISK and zero components at LOW RISK category.
- The comparison of current and overall future risk distribution shows that there is no change in risk levels up to 10 years without doing any inspection. All tanks floors, ten (10) components, are at POF-2 whereas all other components (tank shell courses) are at POF-1.

The summary of the Financial-risk analysis results with an aim of extending Turnaround *overhaul* interval from 10 to 15 years are presented in Figures - 5 and 6 on the risk matrixes.

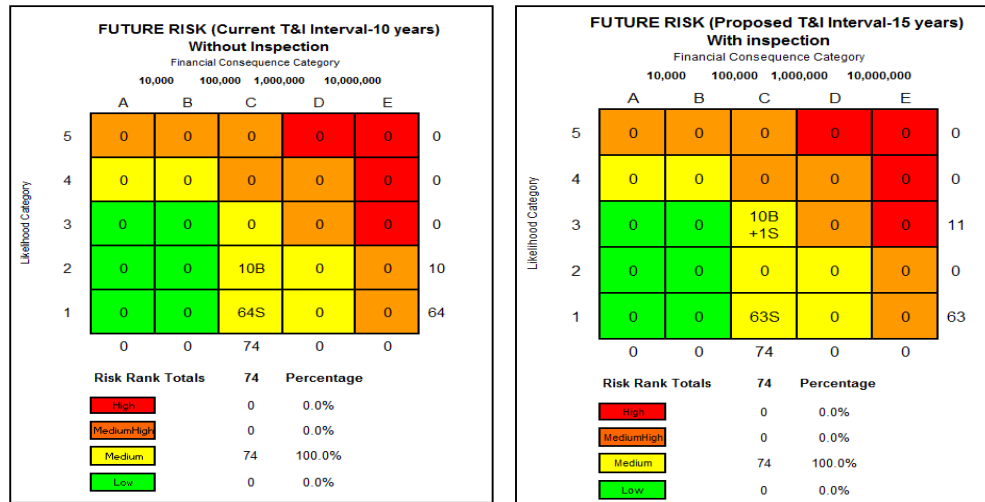
**Figure 6 - Risk Comparison with 5-Years TURNAROUND Extension**

**Note:** “B” represents the Bottom/Floor and “S” represents the Shell course of the tank in the risk matrix.

The main observations from Figure 6 are as follows:

- The overall future risk distribution with inspection (at proposed Turnaround interval-15years) for seventy four (74) components tanks shows zero components at HIGH RISK, zero components at MEDIUM HIGH RISK, seventy four (74) components (100%) at MEDIUM RISK and zero components at LOW RISK category. Ten (10) components are the tank bottom plates at POF-3, one (1) shell course (D-0115-Course 2; due to high corrosion rate of 10.9 mpy) at POF-3, whereas all other components (tank shell courses) are at POF-1.

- From the above comparison, at proposed TURNAROUND *Overhaul* interval of 15 years, if inspection are performed then ten (10) tanks bottom plates and one (1) tank shell course will stay at MEDIUM RISK. Hence, **there is an option of extending the TURNAROUND overhaul interval from 10 to 15 years**. However, it is highly recommended to perform all inspection as per calculated inspection plan in order to lower or at least maintain the risk at same level.

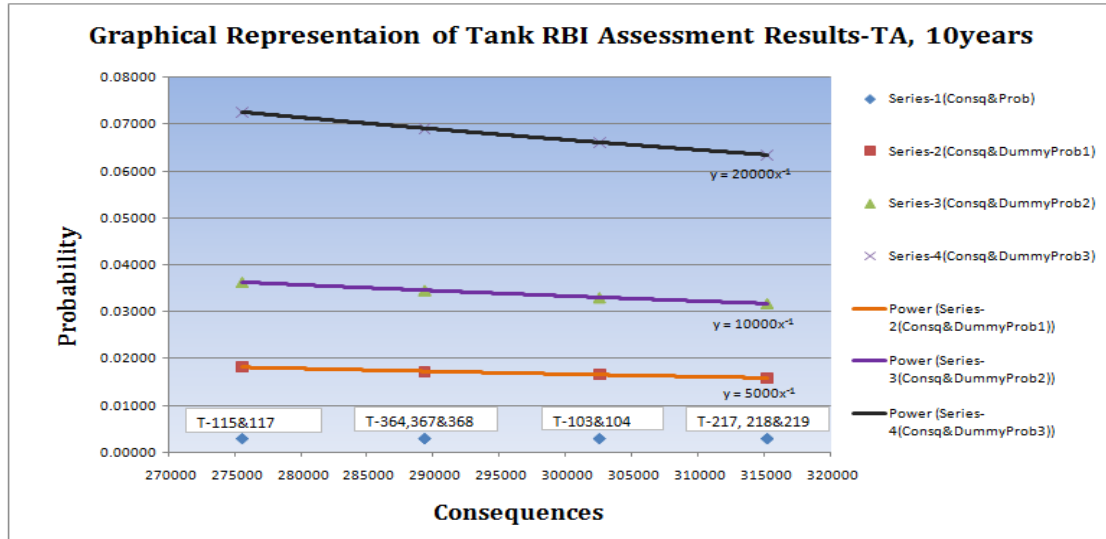
Tank bottoms are selected to develop the risk plot by using probability and consequences against different risk targets (\$ 5000, \$10,000 and \$20,000) which are showing the placement of tanks bottom on charts in Figure-7 and Figure-8.

Figure 7 - Tank's Graphical Representation for Current TURNAROUND – 10 years

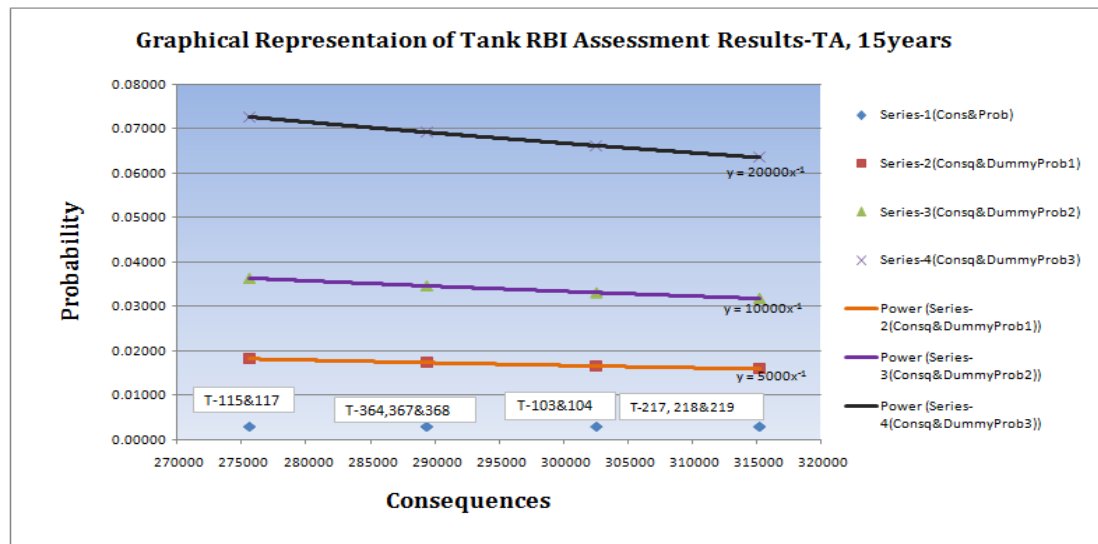
Figure 8 - Tank's Graphical Representation for Proposed TURNAROUND – 15 years
